THE CHURCH AT DEREAGZI: A PRELIMINARY REPORT

JAMES MORGANSTERN

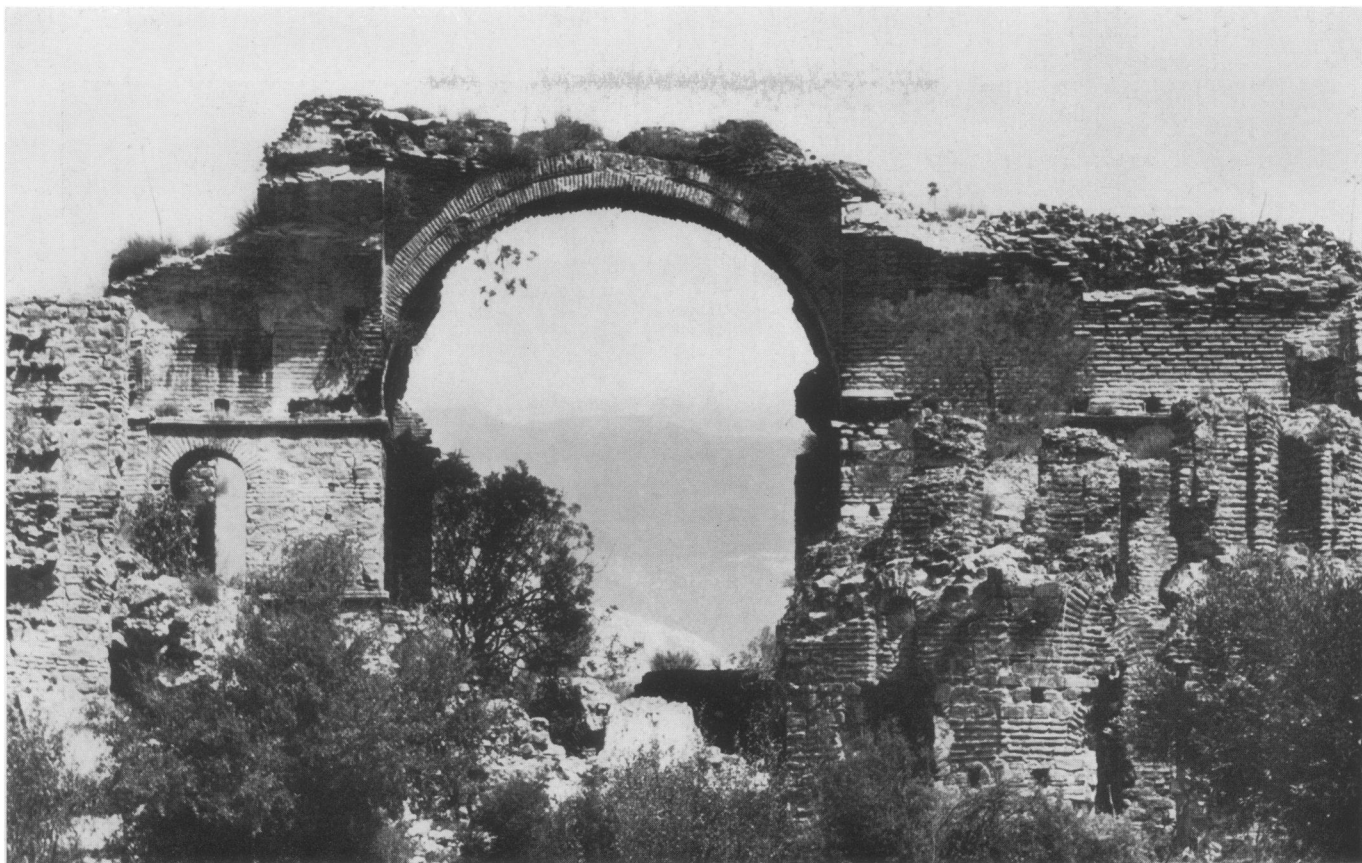
2. Church and South Octagon, looking North

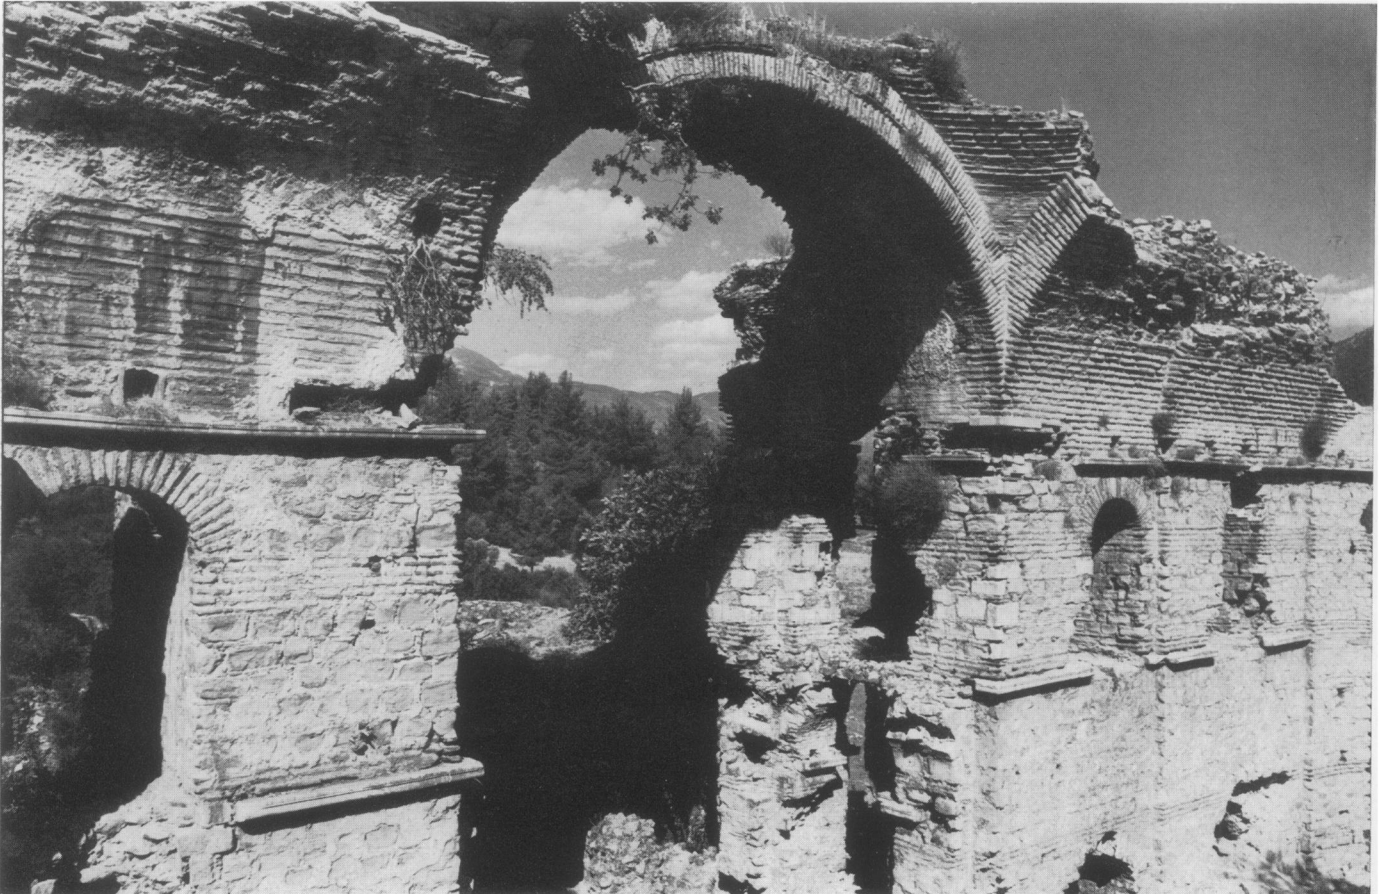
5. Northern Half of Church Interior, looking Northeast

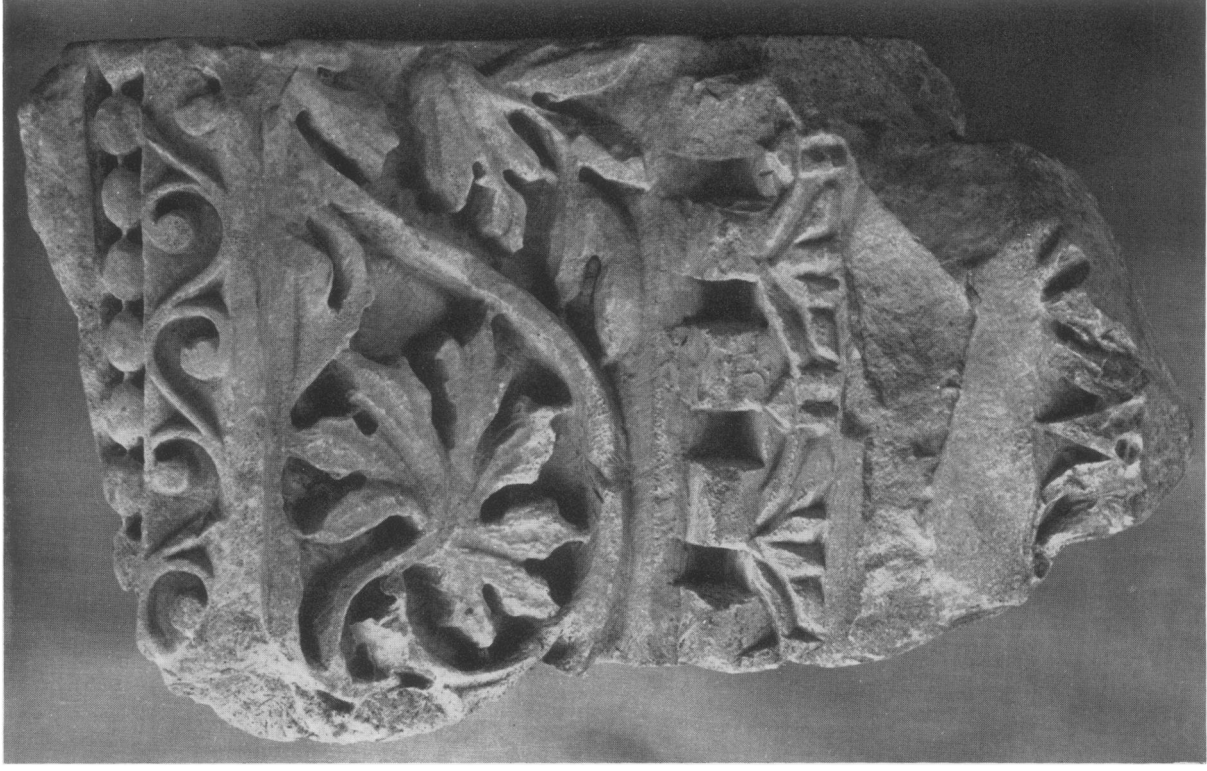
7. Architrave

Additional evidence of an earlier building at Dereagzı is provided by a fragment of a large architrave (fig. 7).³¹ It was found in 1965, by Bay I. Dediler, ca. 25–30 m. west of the church. Its exact provenance is not known. The architrave (39 cm. × 26 cm. × 13–30 cm.) consists of two basic portions: a base and an upper portion which projects forward from the base. The base is composed of a plain central molding (damaged) decorated by stylized palmette festoons at the top, set between an egg-and-dart (damaged) and a plain molding supported by a row of dentils. The face of the projecting upper portion is decorated by a string of astrigals and a somewhat stylized running tendril, surrounded by thin fillets (damaged). The underside is overgrown by a luxuriant series of grape leaves. The material is again a marble-like limestone. While the treatment of the leaves is somewhat more generalized and the undercutting less pronounced, the fragment from Dereagzı is very reminiscent of sculpture from the church of St. Polyeuctos in Istanbul, datable to the years 524–527.³²

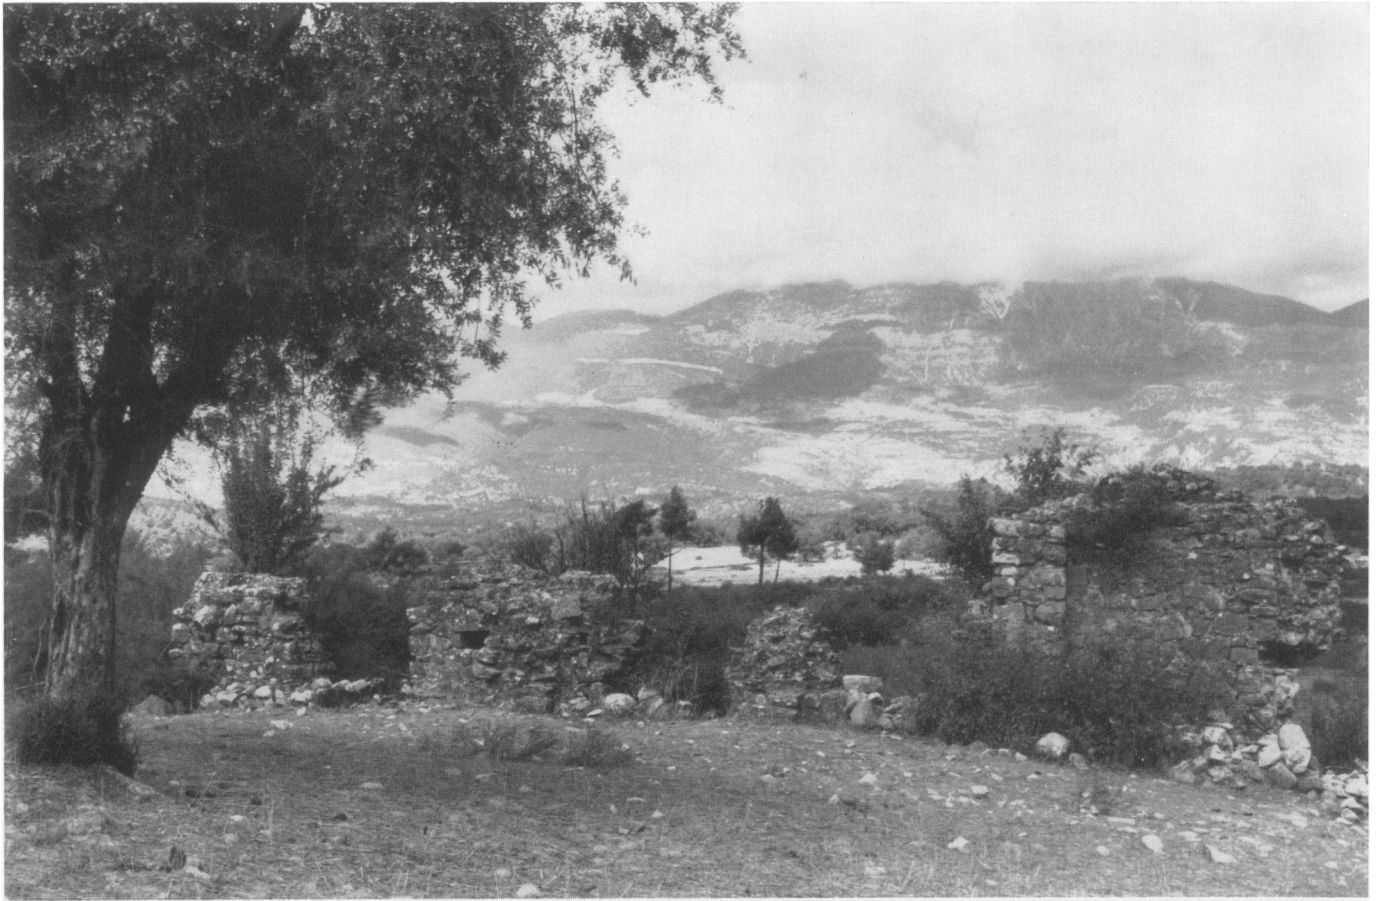
9. South Face of Wall (A), looking North

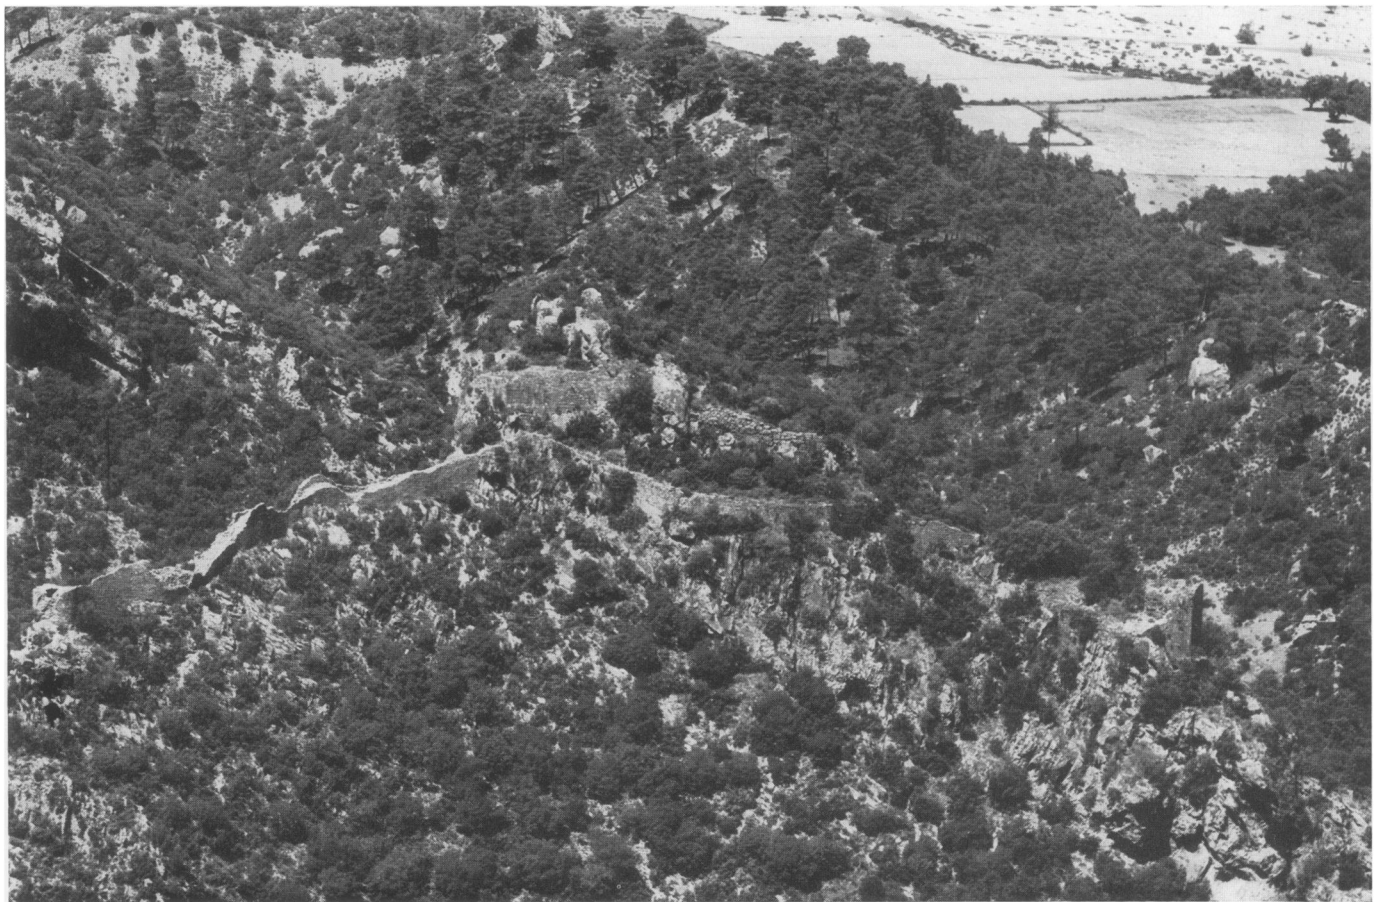
10. Fort, looking West. Spur Wall visible at Left, Pentagonal Tower at Right
